BENEFITS OF USING AN ROV TO CONDUCT AS1851-2012 TANK INSPECTIONS

1. AS1851 Legislative Requirements

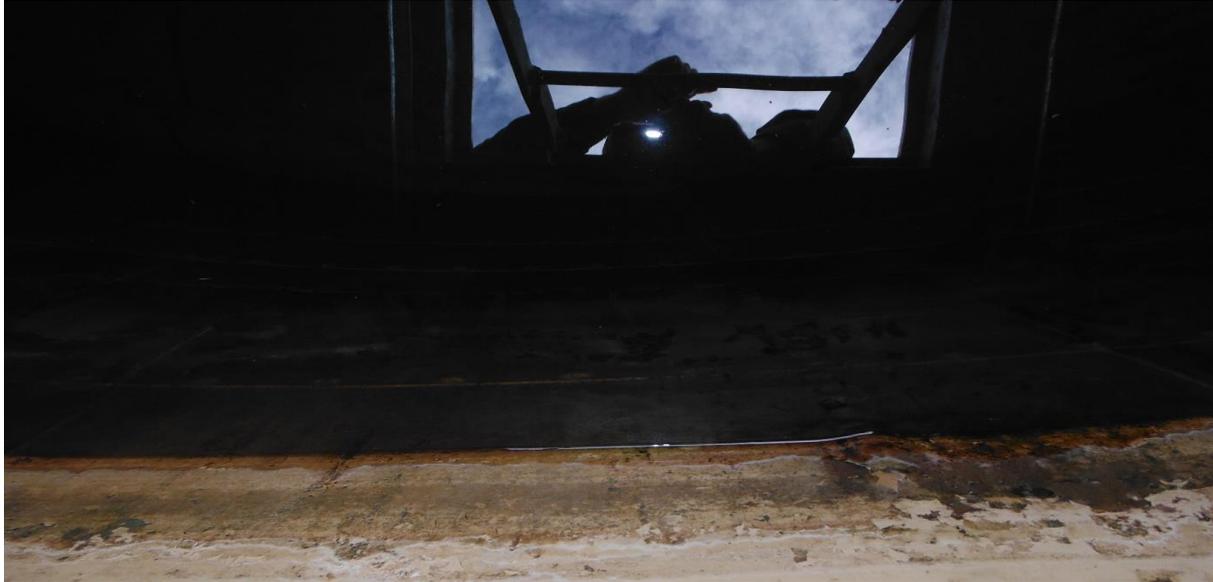
The view from the hatch of a 5.24m high tank. Visibility is limited to a depth of 2 – 2.5m and is distorted with reflections. Note that while the growth on the liner is visible above the waterline, it is not as clear below the waterline.

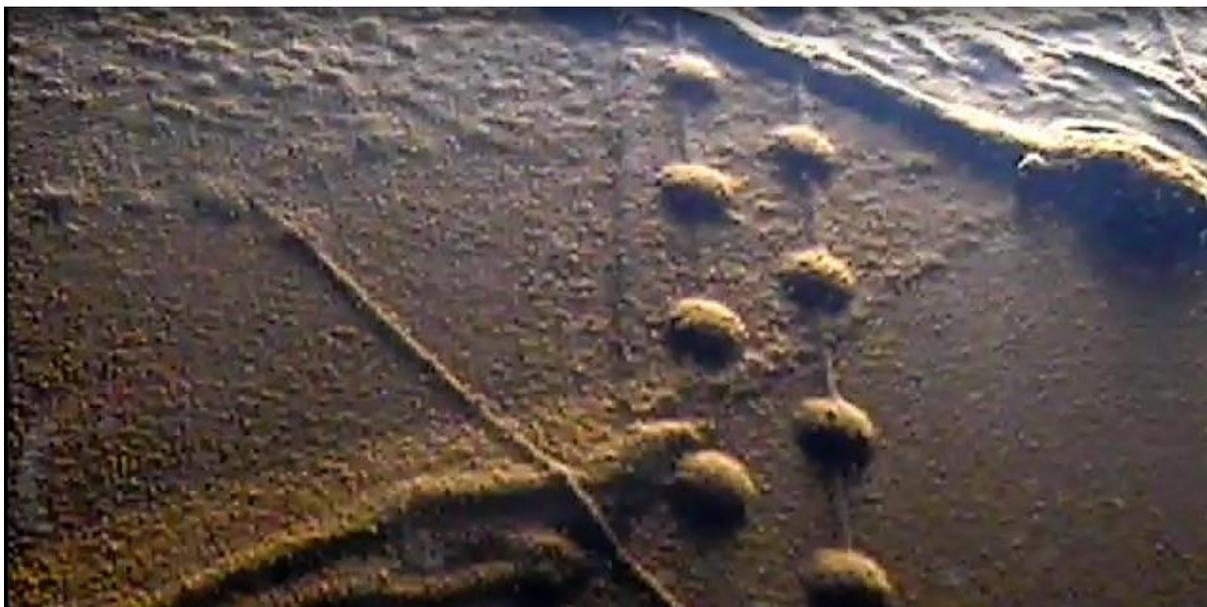
Table 5.4.3, 3.6 – Corrosion “Check for corrosion of all external components and surfaces, and internal components as far as is safe to do so from the top inspection/access hatch”.

The bubbles behind the liner are rust caused by water sitting behind the liner. The rust will eventually penetrate the liner causing leakage, as well as corroding the panels from the inside. These bubbles are not visible from the hatch and require an internal inspection to be identified.

The advantage of using an ROV instead of a full tank empty in this circumstance is that the rust is not disturbed and further damage to the liner during unnecessary empty and fill situations is avoided. Once a tank is emptied, the liner generally falls away from the wall so that these issues are not always identifiable.

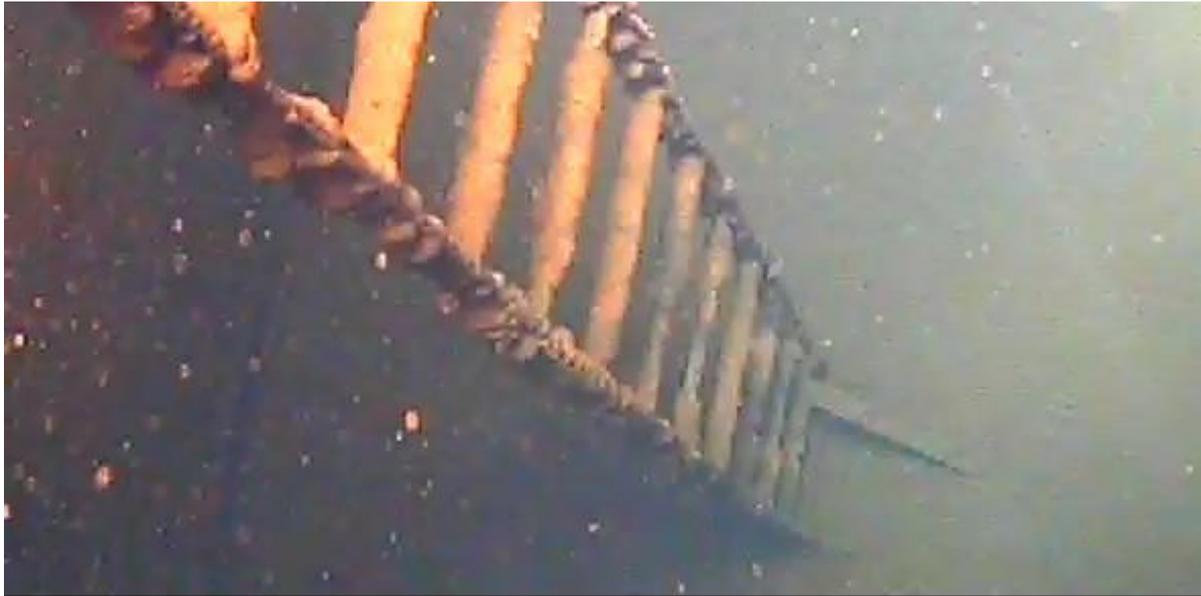
Table 5.4.3, Item 3.8 – Ladder “Check the ladder system is secure and free from corrosion”.

A rusting and broken ladder with a piece from the upper rungs of the ladder having fallen to the floor. The ladder is in a tank 5.75m high with the still taken from an ROV fitted with auxiliary high powered lighting at approximately 3m depth. At this height, the bottom of the tank is not visible from the hatch. Reliance on this ladder for access and egress poses safety issues for maintenance or inspection personnel. The broken metal falling to the floor of the tank may also have caused damage to the liner resulting in leaking.

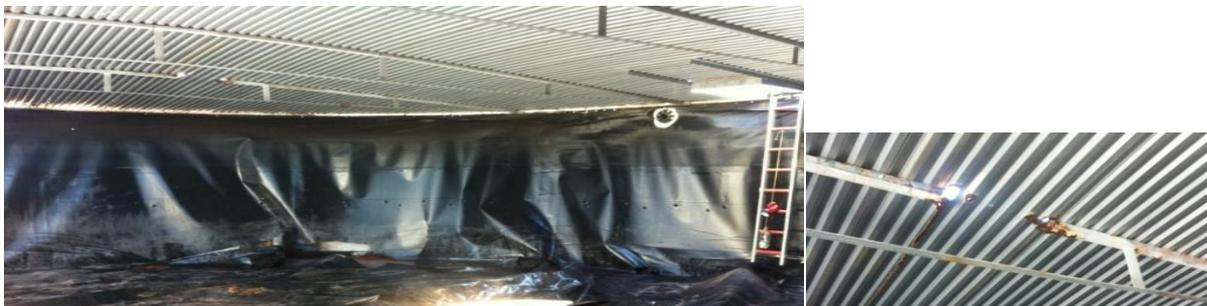
Rusted truss distance from hatch

A visual only hatch inspection where a rusted truss was not identified from the hatch. The rusted truss was identified during a subsequent reline by personnel working inside the tank.

Located on a remote site, this resulted in a costly return to site for the client when the reline and truss repair could have been conducted at the same time. Additionally, personnel walking on the roof were unknowingly exposed to the roof failing under their weight.

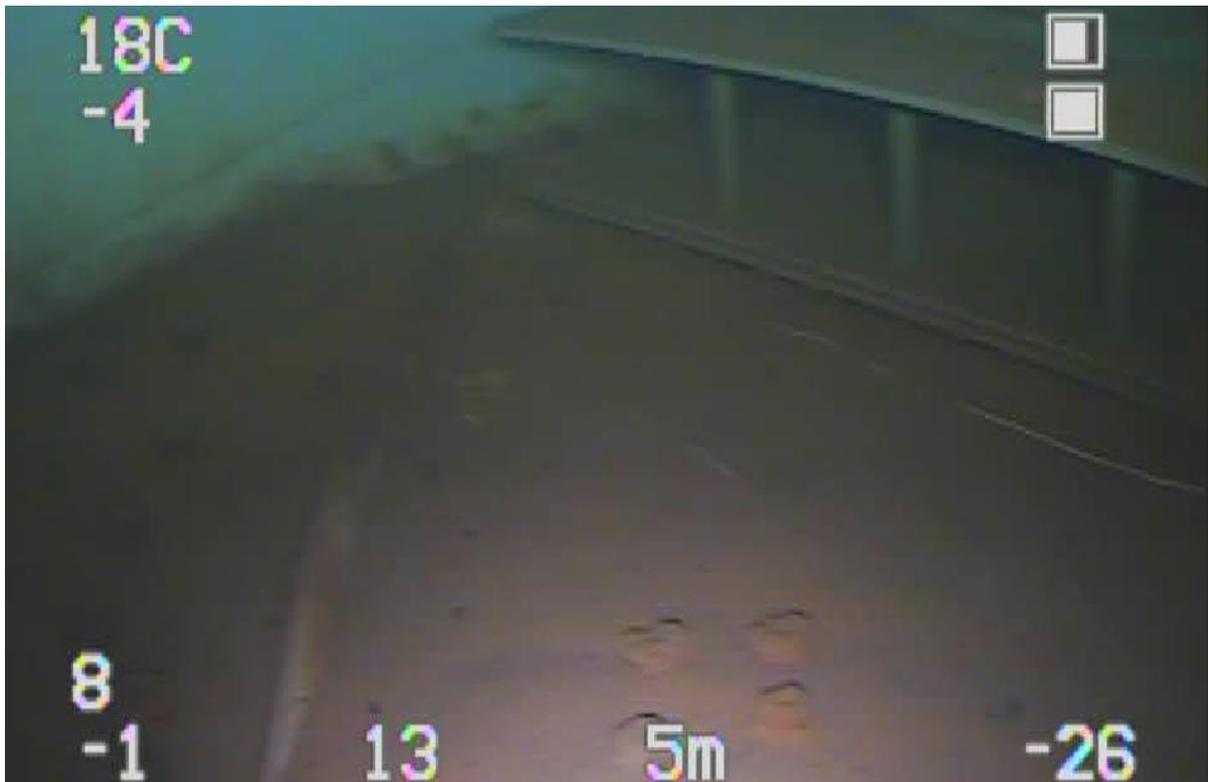
Table 5.4.3, 3.11 – Foreign objects “Check for internal foreign objects visually through the top inspection/access hatch”.

Nuts sitting on the floor of the tank can be sucked into the anti-vortex during emergency use and cause pump failure. The objects captured by the ROV are in a 6m high tank and would not be visible from the hatch. This picture also identifies that scheduled maintenance may not have been carried out due to the lack of disturbance to sludge around the fitting.

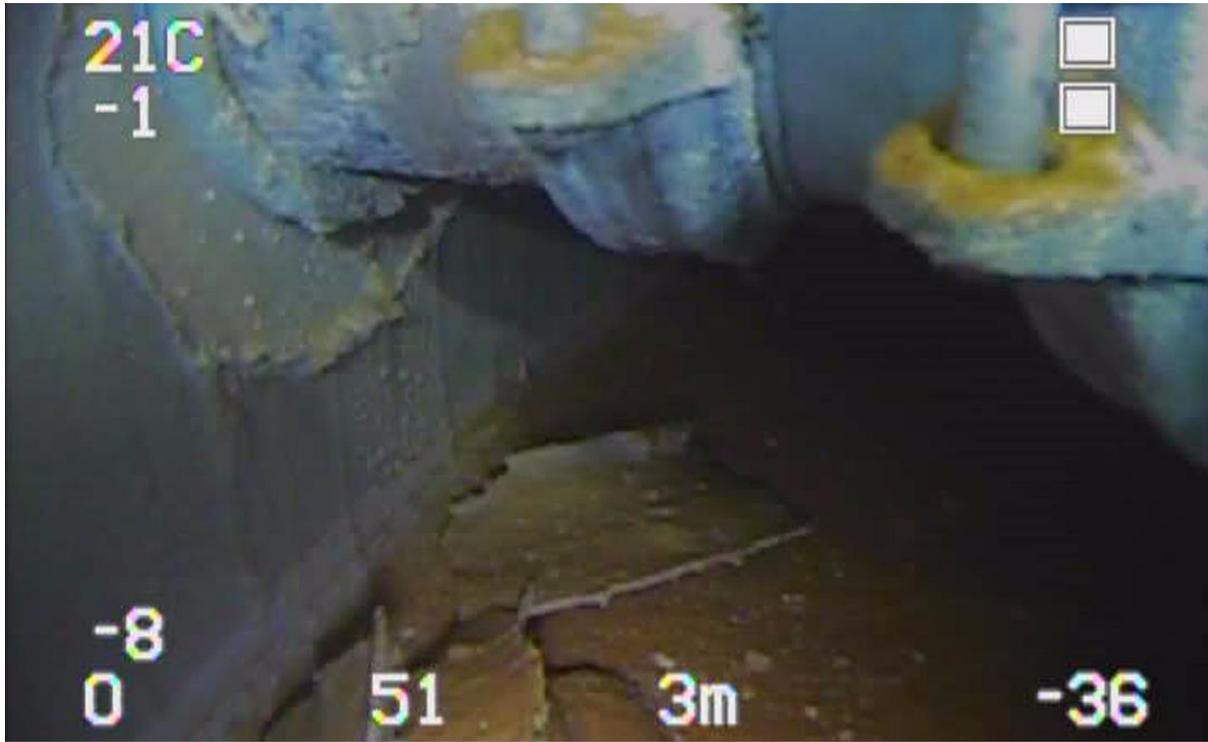
Table 5.4.3, 3.16 – Gaskets and seals “Check the condition of all gaskets and sealants”.

Waterproofing failure around the anti-vortex in a one year old concrete tank servicing a multi-storey office development. The chambered configuration of this concrete tank is such that the anti-vortex is not visible from the hatch. Using an ROV to conduct AS1851-2012 internal fire tank inspections

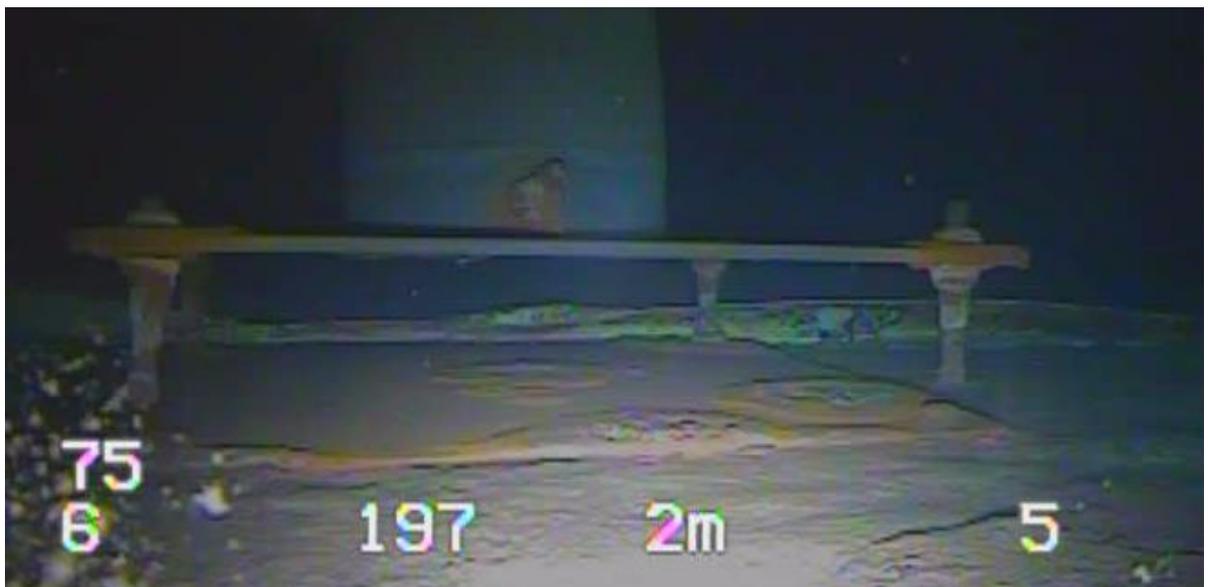
Table 5.4.3, 3.17 – Vortex inhibitor “Check the condition of the vortex inhibitor visually from the access hatch if practicable”.

At only 2m high, while the base fittings in this tank may be visible from the hatch, viewing of the anti-vortex plate is not possible. The anti-vortex pictured shows rusted bolts that can result in the cavitation plate being sucked onto the anti-vortex during use, causing failure.

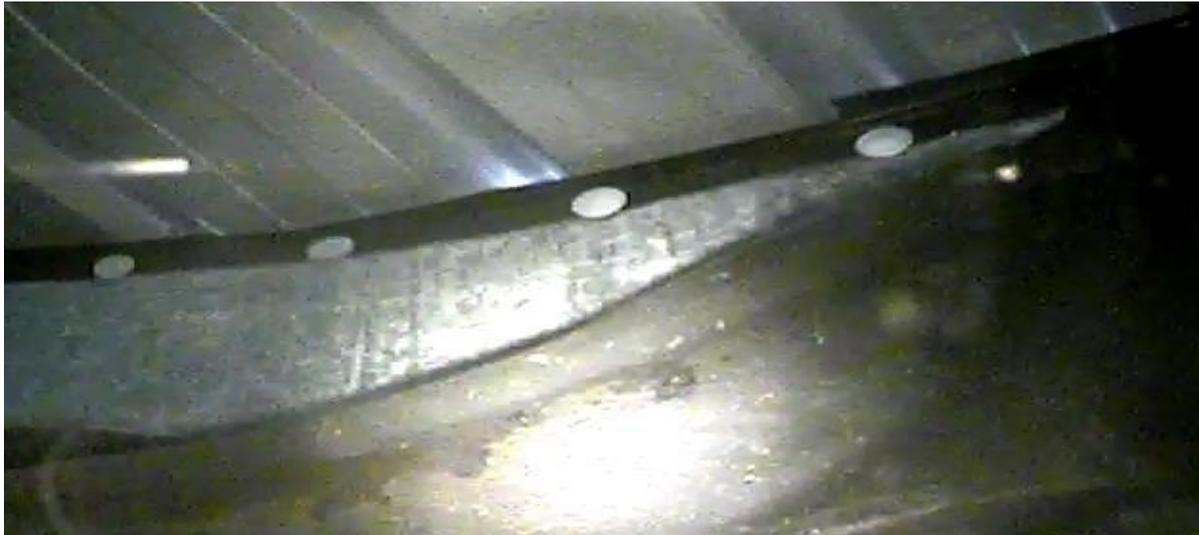
Table 5.4.3, Item 3.21 – Eyelets and other liner fixing systems “Check eyelets, attachment connectors and other mechanical fixings for wear, detachment or corrosion”.

A torn liner allowing water to slip behind the liner and cause wall panel corrosion which is not visible externally until significant repairs are required. It is not possible to view the full liner attachment of a tank with a hatch only inspection. This picture was taken by the ROV about 110 degrees west of the hatch. Using an ROV to conduct AS1851-2012 internal fire tank inspections.

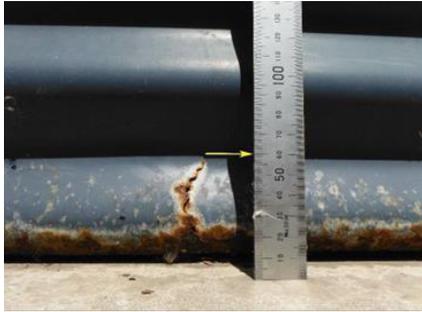
Cause

Corrosion to the bottom ring of a steel wall panel can be missed during routine inspections by untrained personnel. The tank above had been signed off as being inspected for corrosion on an annual basis. While the corrosion may not have appeared significant the resulting tank explosion was catastrophic and could have been avoided with knowledgeable maintenance inspections and recommendations. You are the end user so what you want is imperative.
